NORTHERN AREA WESTERN CONFERENCE -16<sup>TH</sup> -19<sup>TH</sup> FEBURARY, 2004 VICTORIA, BC

## **Liquid epoxy coatings for today's pipeline coating challenges**

*J Banach*  
*Specialty Polymer Coatings, Inc., Canada*

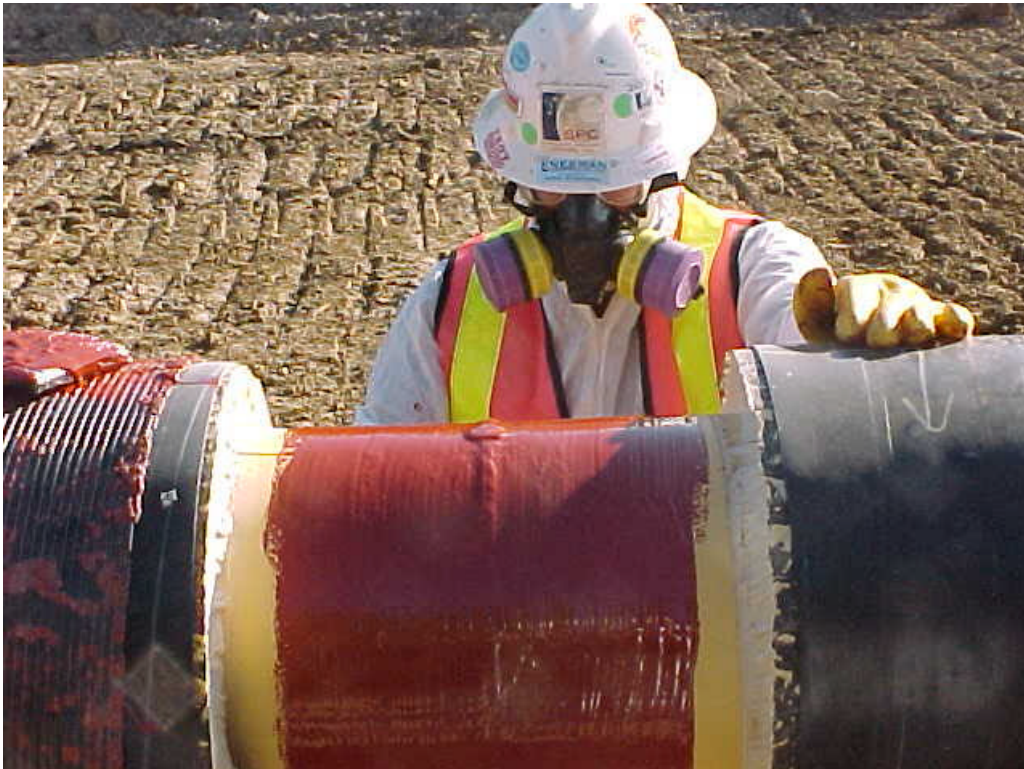
Figure 5 shows a high temperature epoxy applied to a girth weld on a pipe with a surface temperature of 0°C. The pipe surface was blast cleaned and heated to 90°C prior to application of the epoxy coating. The pipeline was designed to operate at 110°C.

**Figure 5. Girth weld coating using high temperature epoxy**

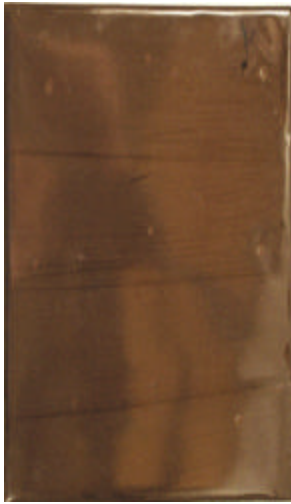
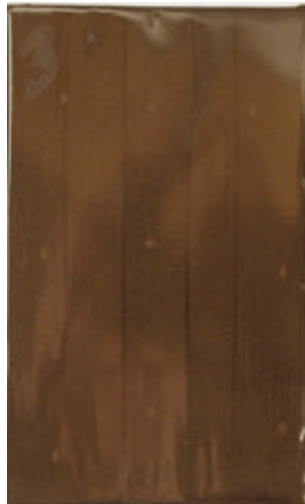
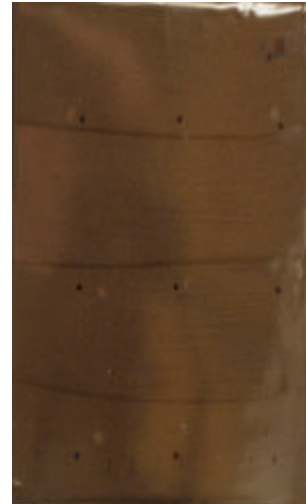
**Figure 7. Impact tests**

Figure 7 shows some of the tested samples at each temperature. The arrows indicate some of the locations of where the sample was impacted. No cracks or other noticeable defects were observed as a result of testing.

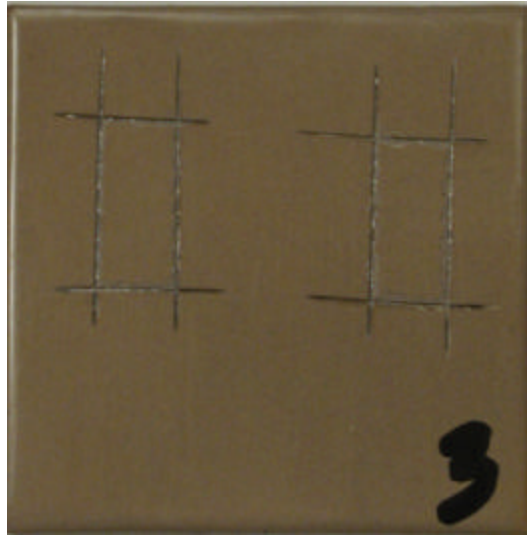
**Figure 8. Adhesion test**

Figure 8 shows the wet adhesion results on one panel before and after the immersion tests conducted at 75°C for 28 days. The coating exhibited a definite resistance to the levering acting applied and maintained excellent adhesion. No blistering occurred as a result of the testing. The test results are given in Table 2.

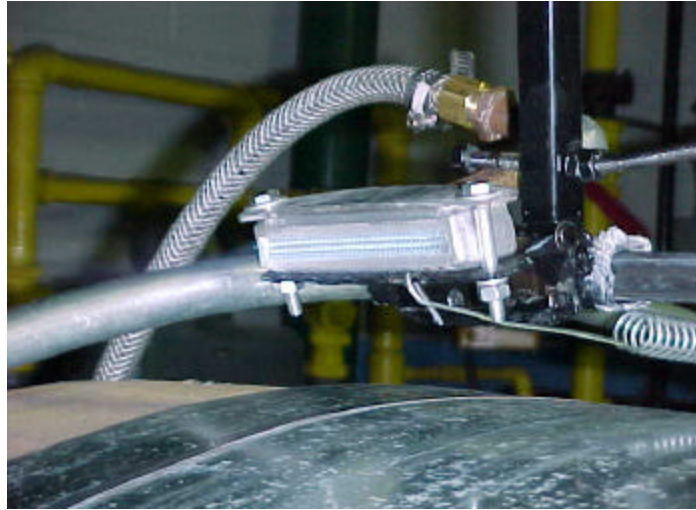
Figure 10 shows a type of burner used for flame treatment.

**Figure 10. Flame treatment burner**

Optimum flame treatment requires a gas flow meter capable of delivering the volumes of gas required for the burner rating, an air flow meter capable of delivering 15% to 25% greater volume of air than is required for normal combustion and a burner designed to give adequate flame pattern for treatment. Prior to flame treatment, the surface energy of the polyethylene should be measure and compared to its surface energy after treatment. Polyethylene has a surface energy of 30 to 40 dynes/cm prior to treatment as measured in accordance with ASTM D 2578-94, Standard Test Method for Wetting Tension of Polyethylene and Polypropylene Films. Optimum surface energy after treatment is 60 to 70 dynes/cm.
